Bulletin No.: PIP5822

PIP5822 Intermittent Extended Crank or Intermittent Crank No Start and DTC P0341 Set

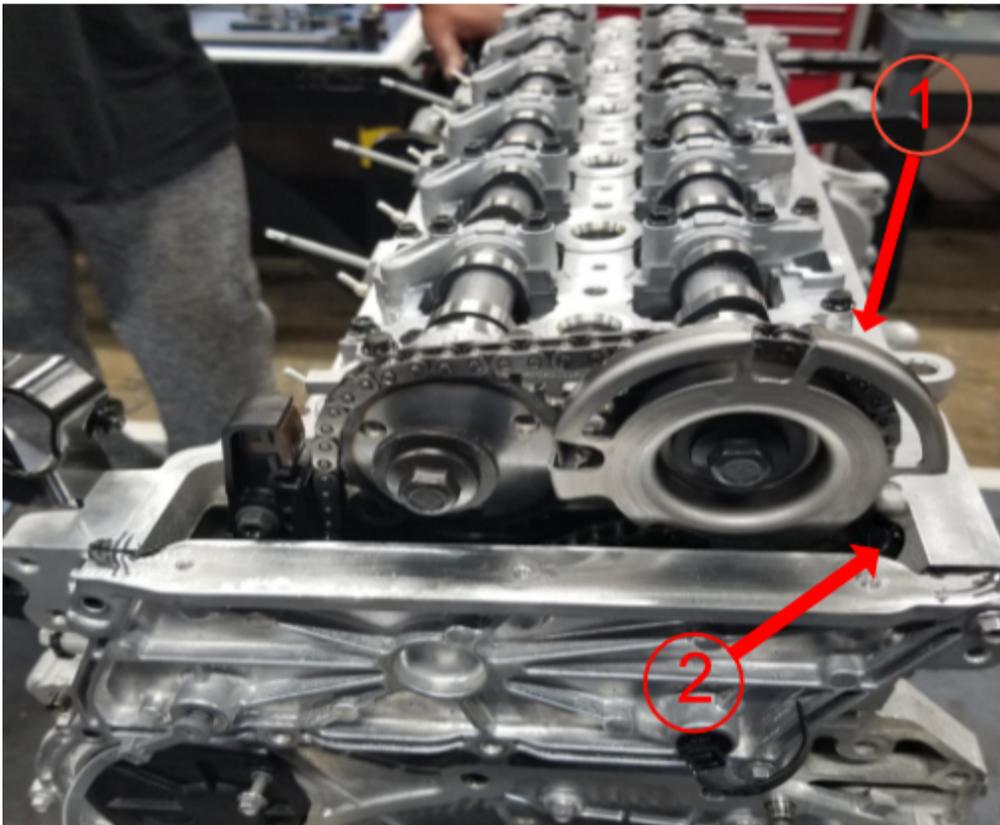
The exciter wheel in the pictures below are for reference only and are NOT bent.

1. Camshaft exciter wheel
2. Camshaft position sensor

Carefully remove the camshaft position sensor and use a borescope to inspect the camshaft position sensor exciter wheel for making contact with the timing chain. If the camshaft position sensor exciter wheel is contacting the timing chain, replace the exciter wheel.

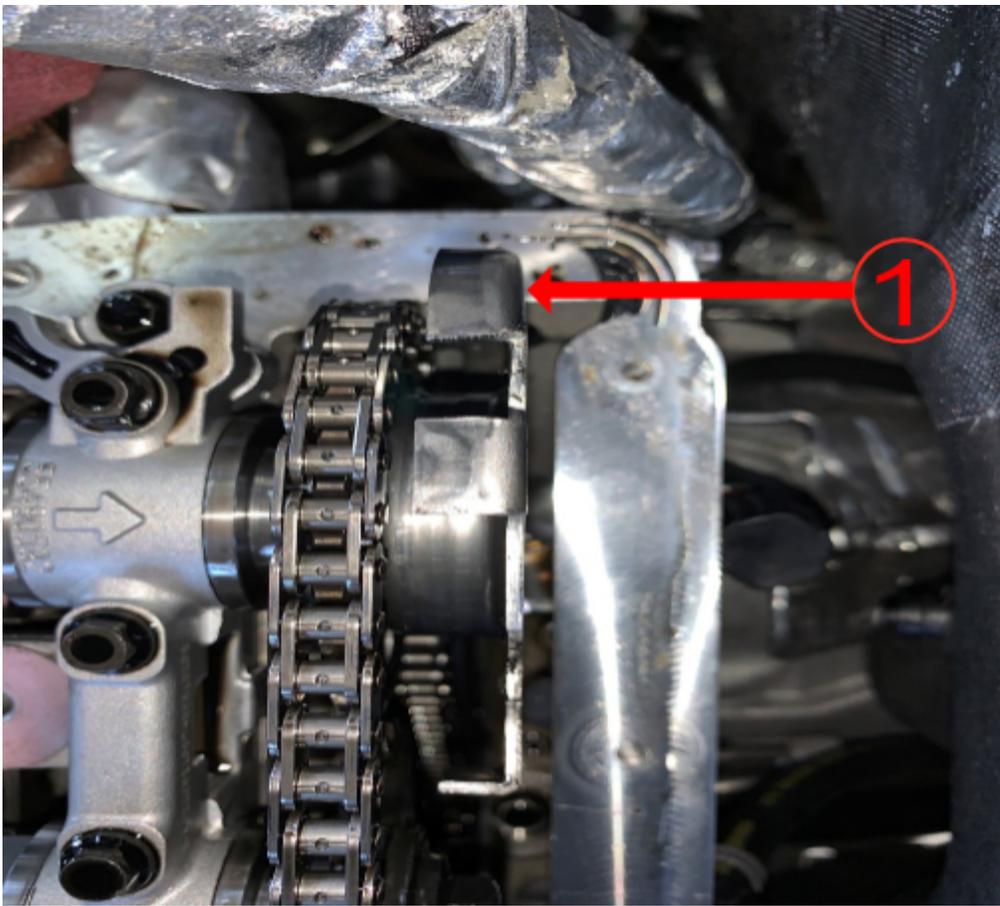
1. Camshaft exciter wheel
